**MULTI-MEDIA SAMPLING REPORT FOR THE
BRANDEIS-BARDIN INSTITUTE
AND
THE SANTA MONICA
MOUNTAINS CONSERVANCY
VOLUME I**

**ROCKWELL INTERNATIONAL CORPORATION
ROCKETDYNE DIVISION
6633 CANOGA AVENUE
CANOGA PARK, CA 91303**

**MCLAREN/HART ENVIRONMENTAL ENGINEERING CORPORATION
16755 VON KARMAN AVENUE
IRVINE, CALIFORNIA 92714**

MCLAREN/HART PROJECT NO. 29403-012

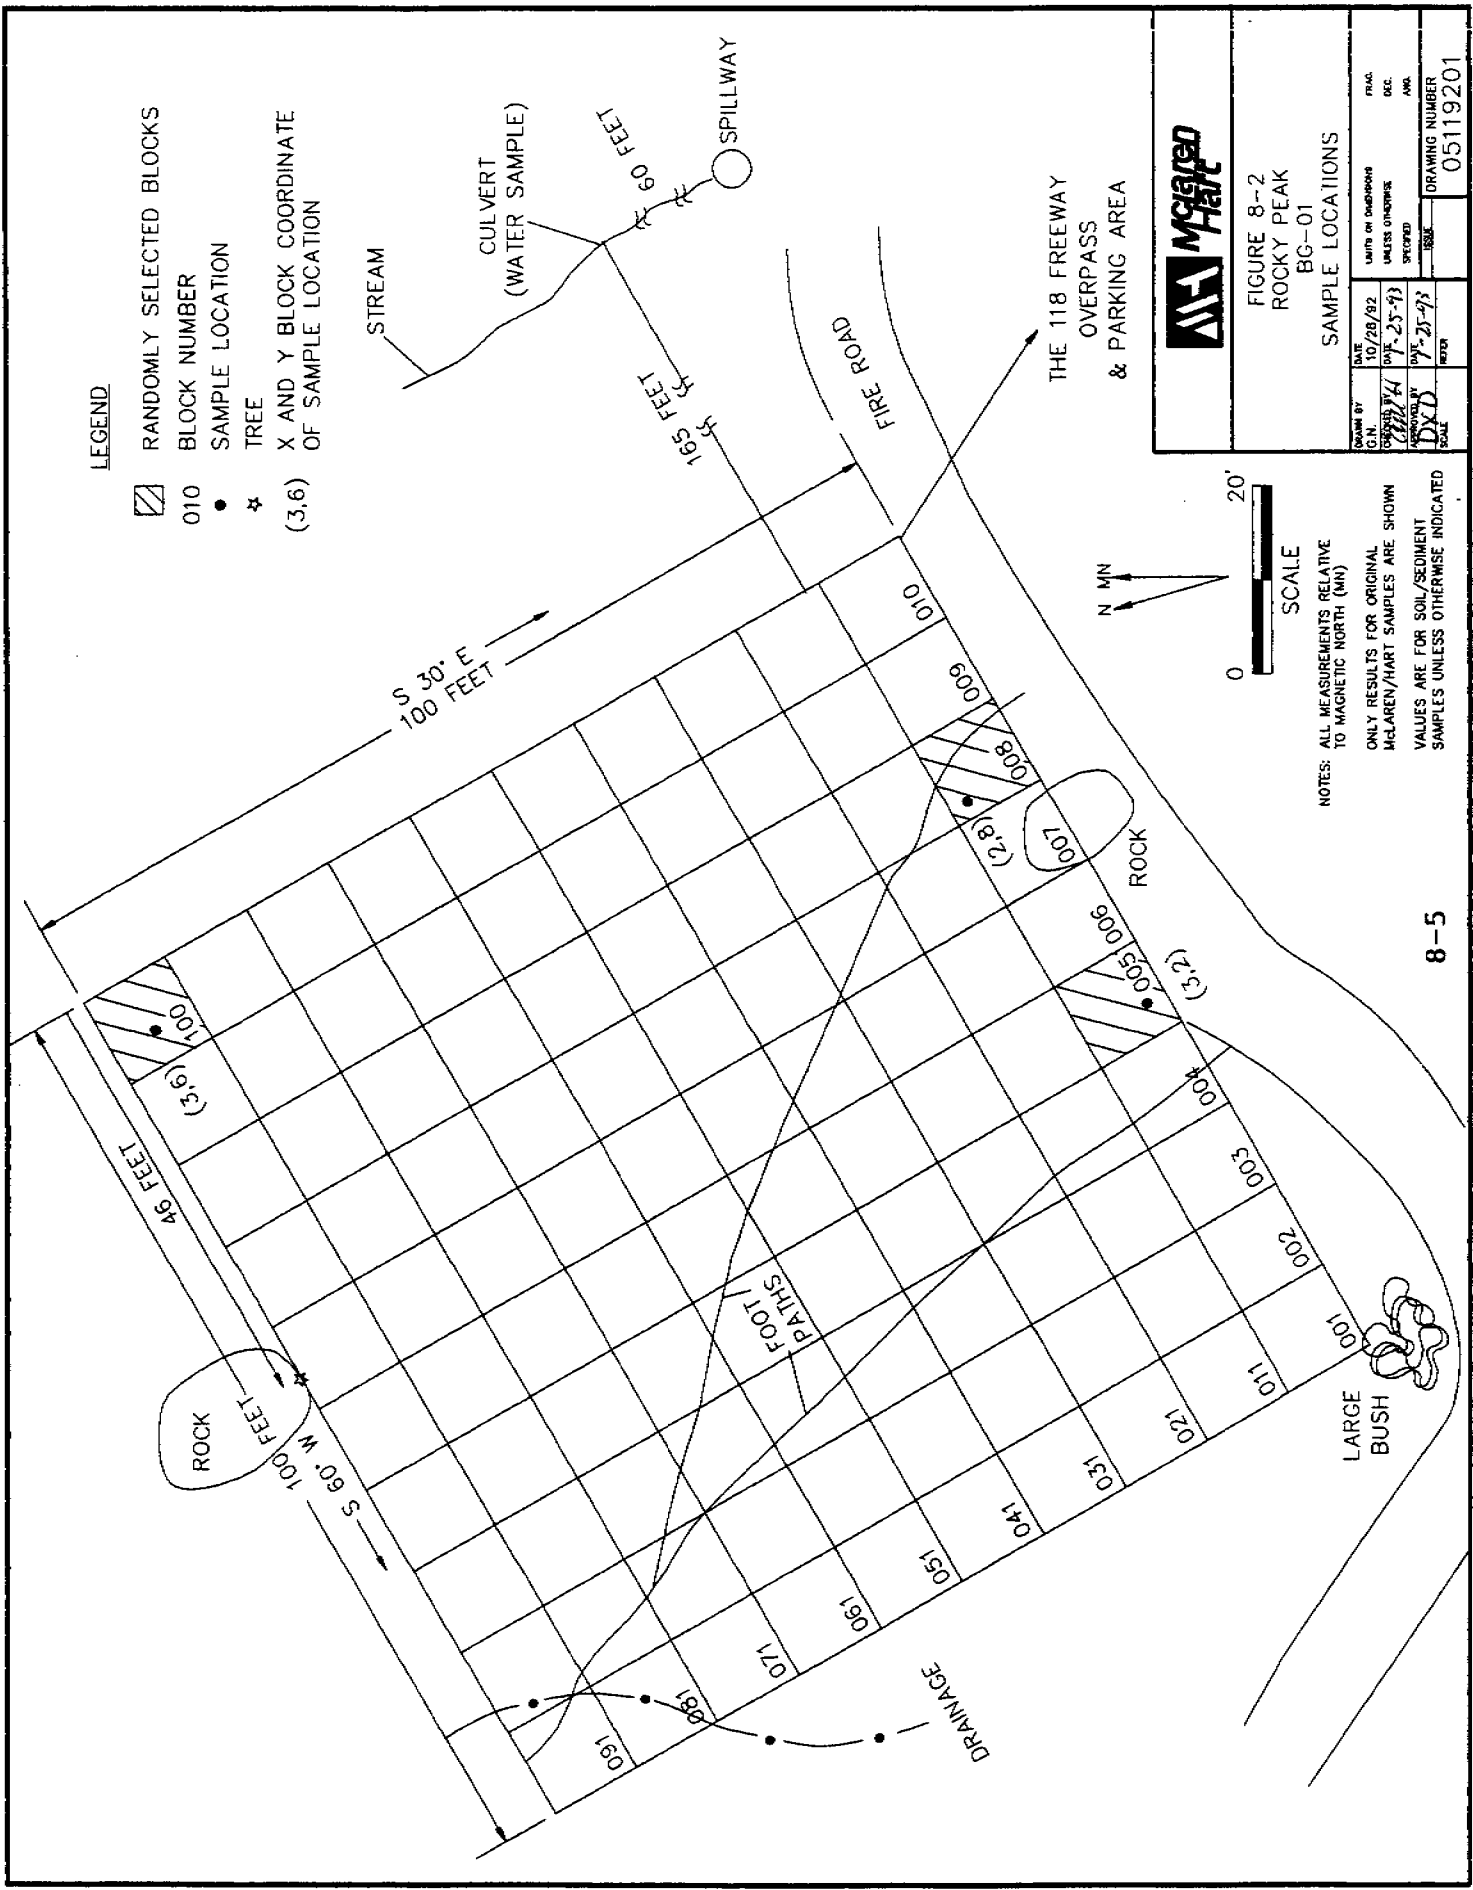
FIGURE 8-2
ROCKY PEAK
BG-01
SAMPLE LOCATIONS

RANDOMLY SELECTED BLOCKS
- 010 BLOCK NUMBER
- SAMPLE LOCATION
- * TREE
- (3,6) X AND Y BLOCK COORDINATE OF SAMPLE LOCATION

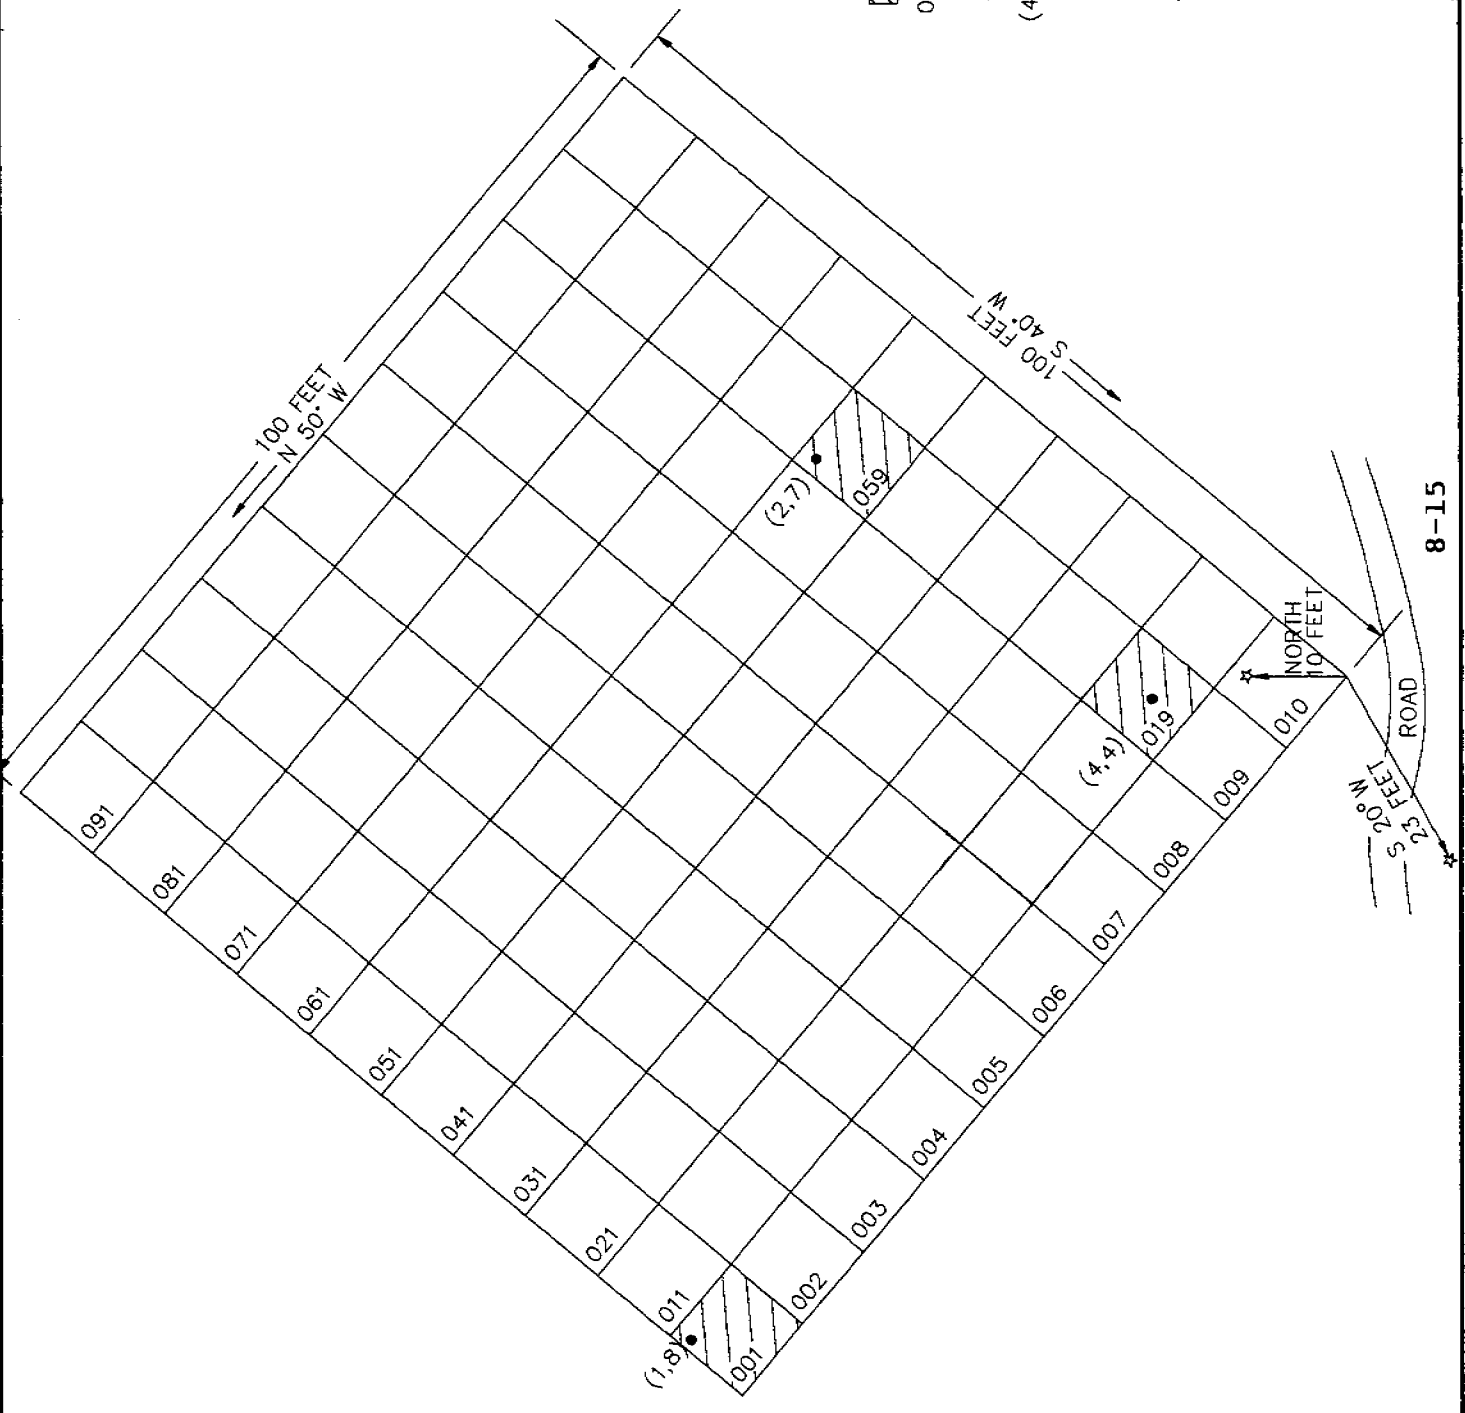
FIGURE 8-4
 BELL CANYON
 BG-03
 SAMPLE LOCATIONS

- ▨ RANDOMLY SELECTED BLOCKS
- 010 BLOCK NUMBER
- SAMPLE LOCATION
- * TREE
- (4,4) X AND Y BLOCK COORDINATE
- (4,4) OF SAMPLE LOCATION

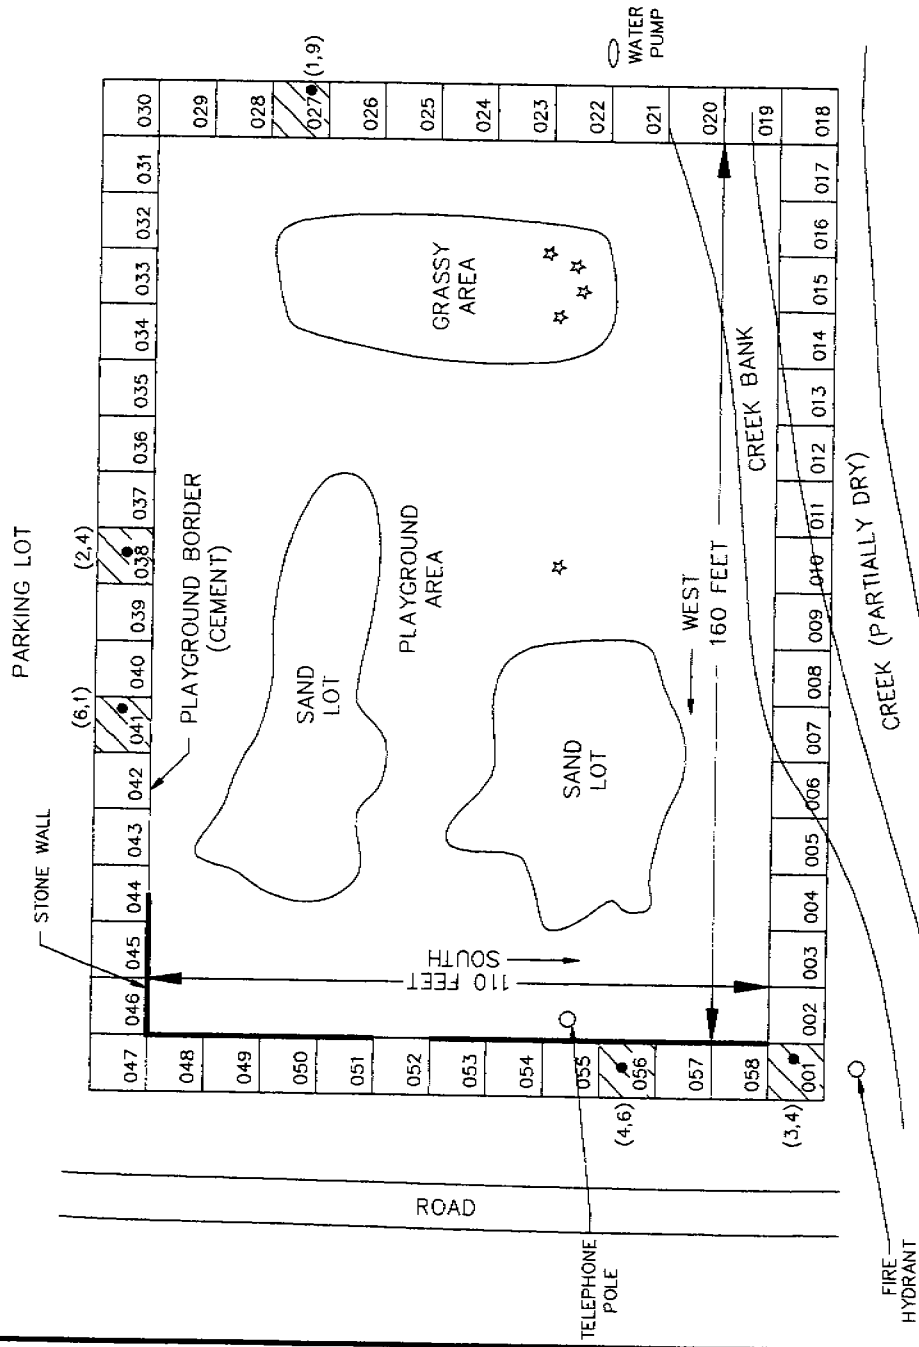
FIGURE 9-1
 PERIMETER OF THE PLAYGROUND
 BB-01
 SAMPLE LOCATIONS

- ◻ RANDOMLY SELECTED BLOCKS
- 010 BLOCK NUMBER
- SAMPLE LOCATION
- ☆ TREE
- (4,6) X AND Y BLOCK COORDINATE OF SAMPLE LOCATION

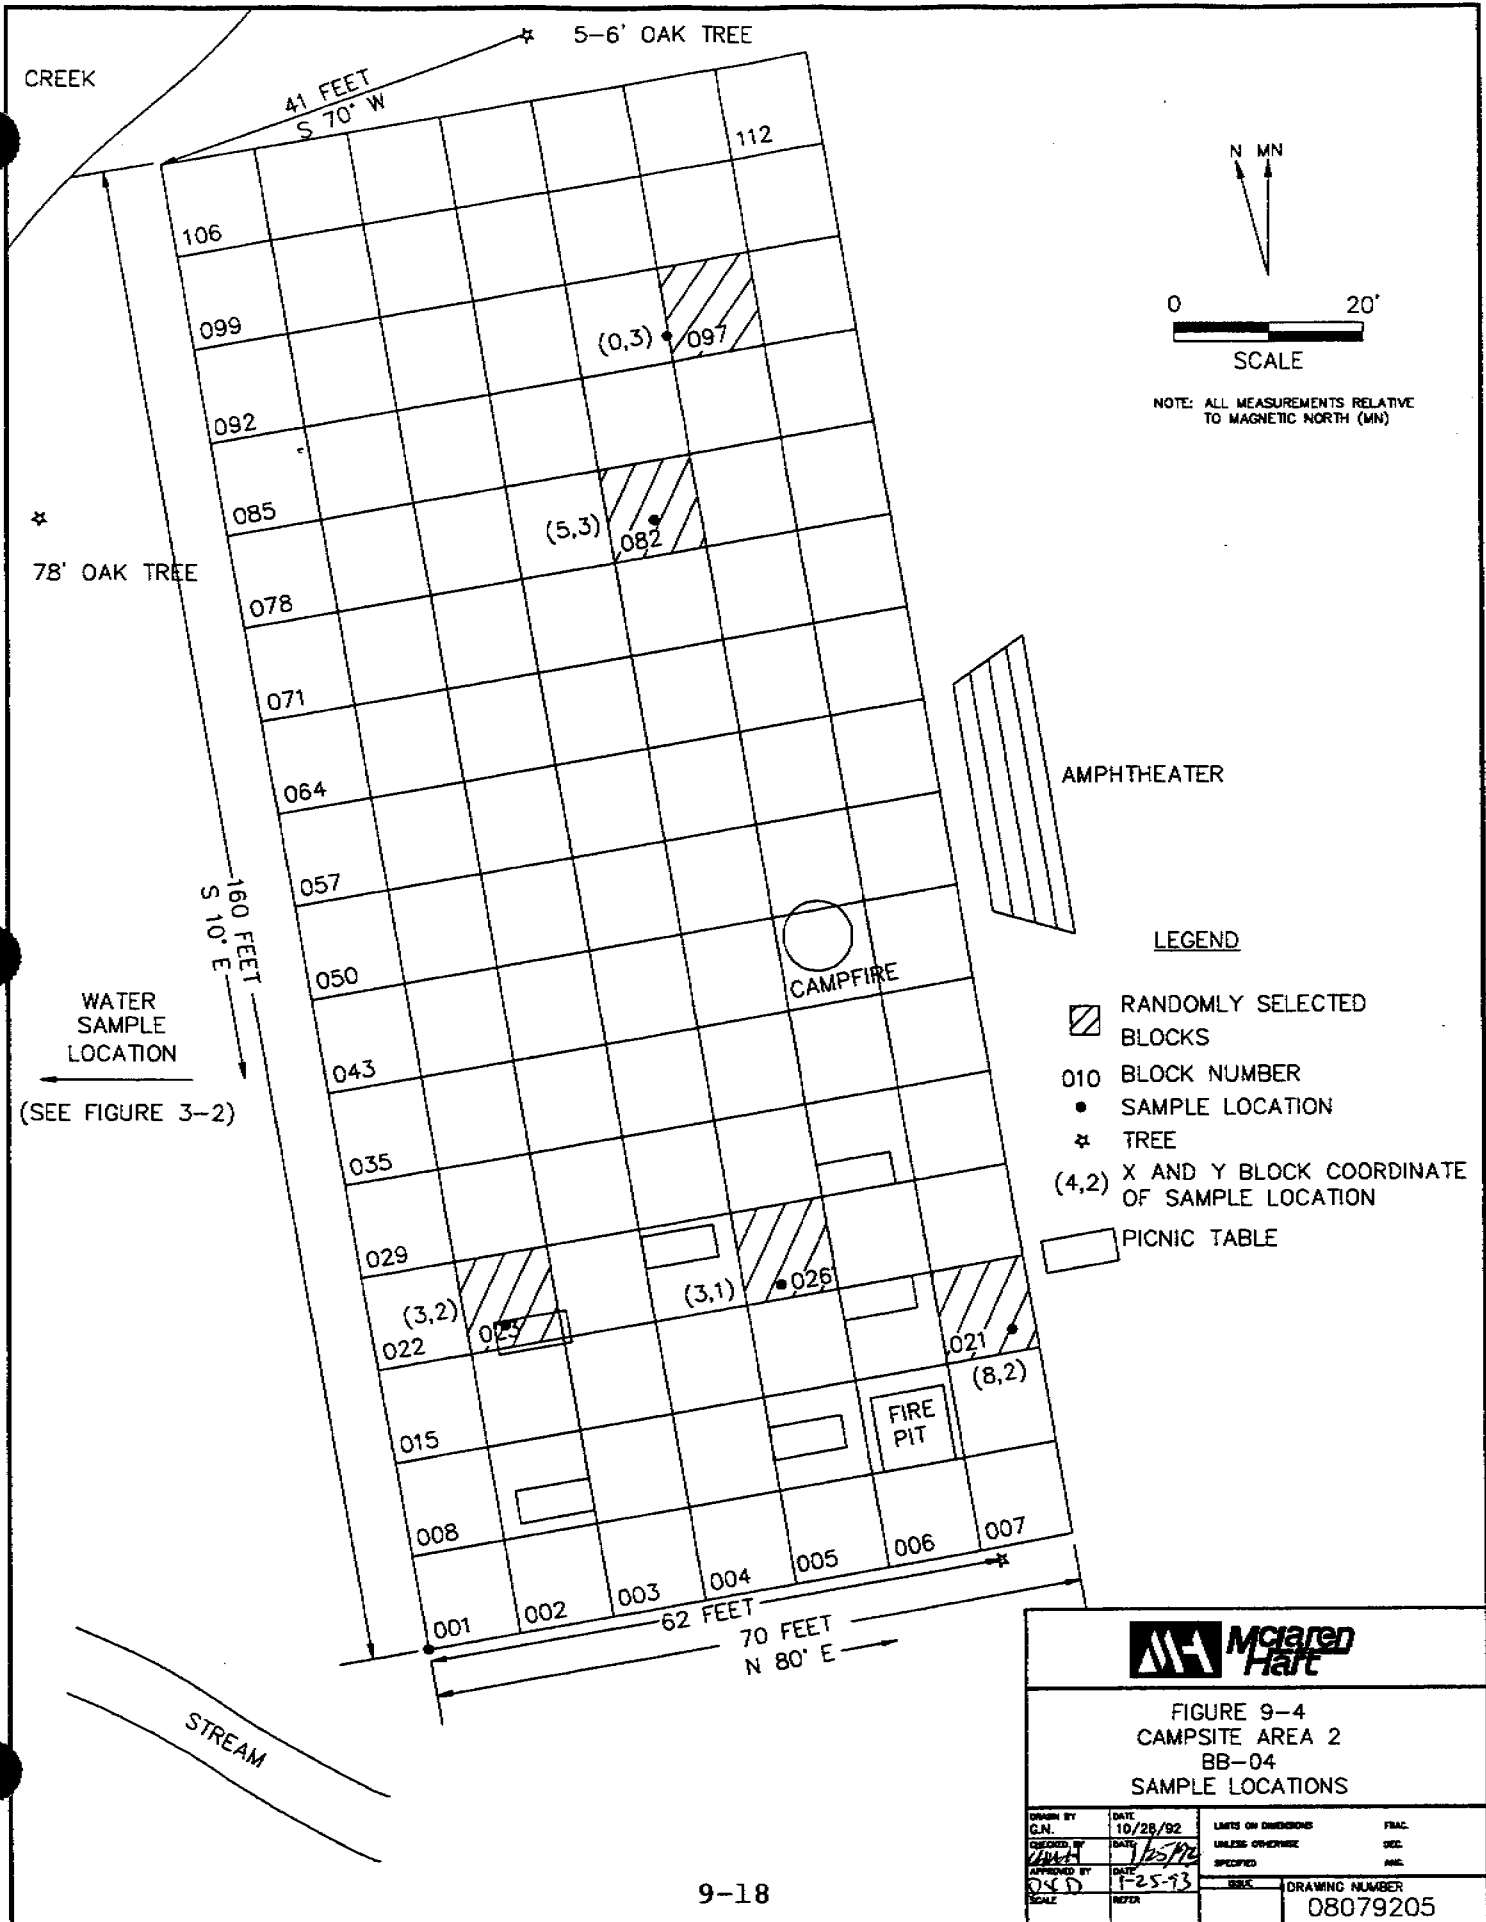
FIGURE 9-4 CAMPSITE AREA 2 BB-04 SAMPLE LOCATIONS	
		<small>DRAWN BY</small> G.N.	<small>DATE</small> 10/28/92
<small>DESIGNED BY</small> J.S.D.	<small>DATE</small> 1/25/93	<small>SCALE</small> 1"=25'-13"	<small>DRAWING NUMBER</small> 08079205

A surface water sample was collected from a running stream located approximately 450 feet downstream from the amphitheater. The water flowed along a concrete stream bed at the point where the samples were collected. A complete set of water samples was collected and split with the USEPA. No chemicals or radionuclides above detection or reporting limits, respectively, were detected in the surface water samples at Campsite Area 2. Chemical and radionuclide analytical data for the surface water samples are summarized in Tables 9-11 and 9-12.

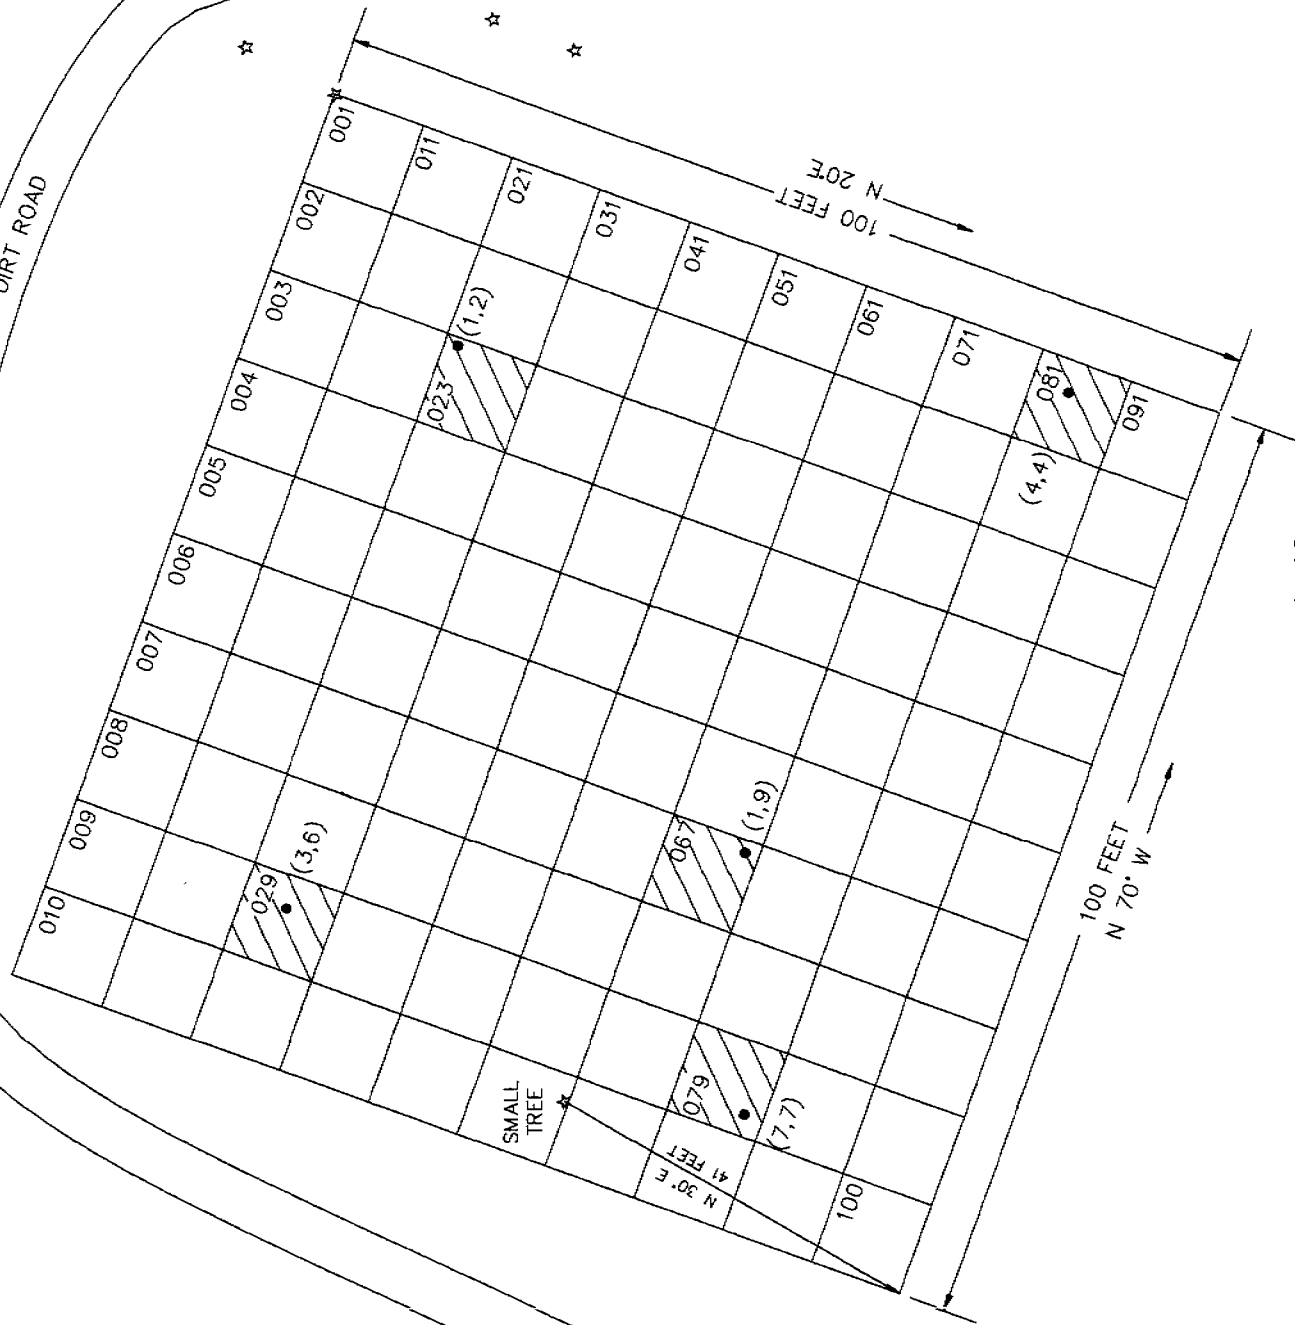
FIGURE 9-10
POTENTIAL DEVELOPMENT SITE 3
BB-10
SAMPLE LOCATIONS

- ☐ RANDOMLY SELECTED BLOCKS
- 010 BLOCK NUMBER
- SAMPLE LOCATION
- ☆ TREE
- (4,2) X AND Y BLOCK COORDINATE OF SAMPLE LOCATION

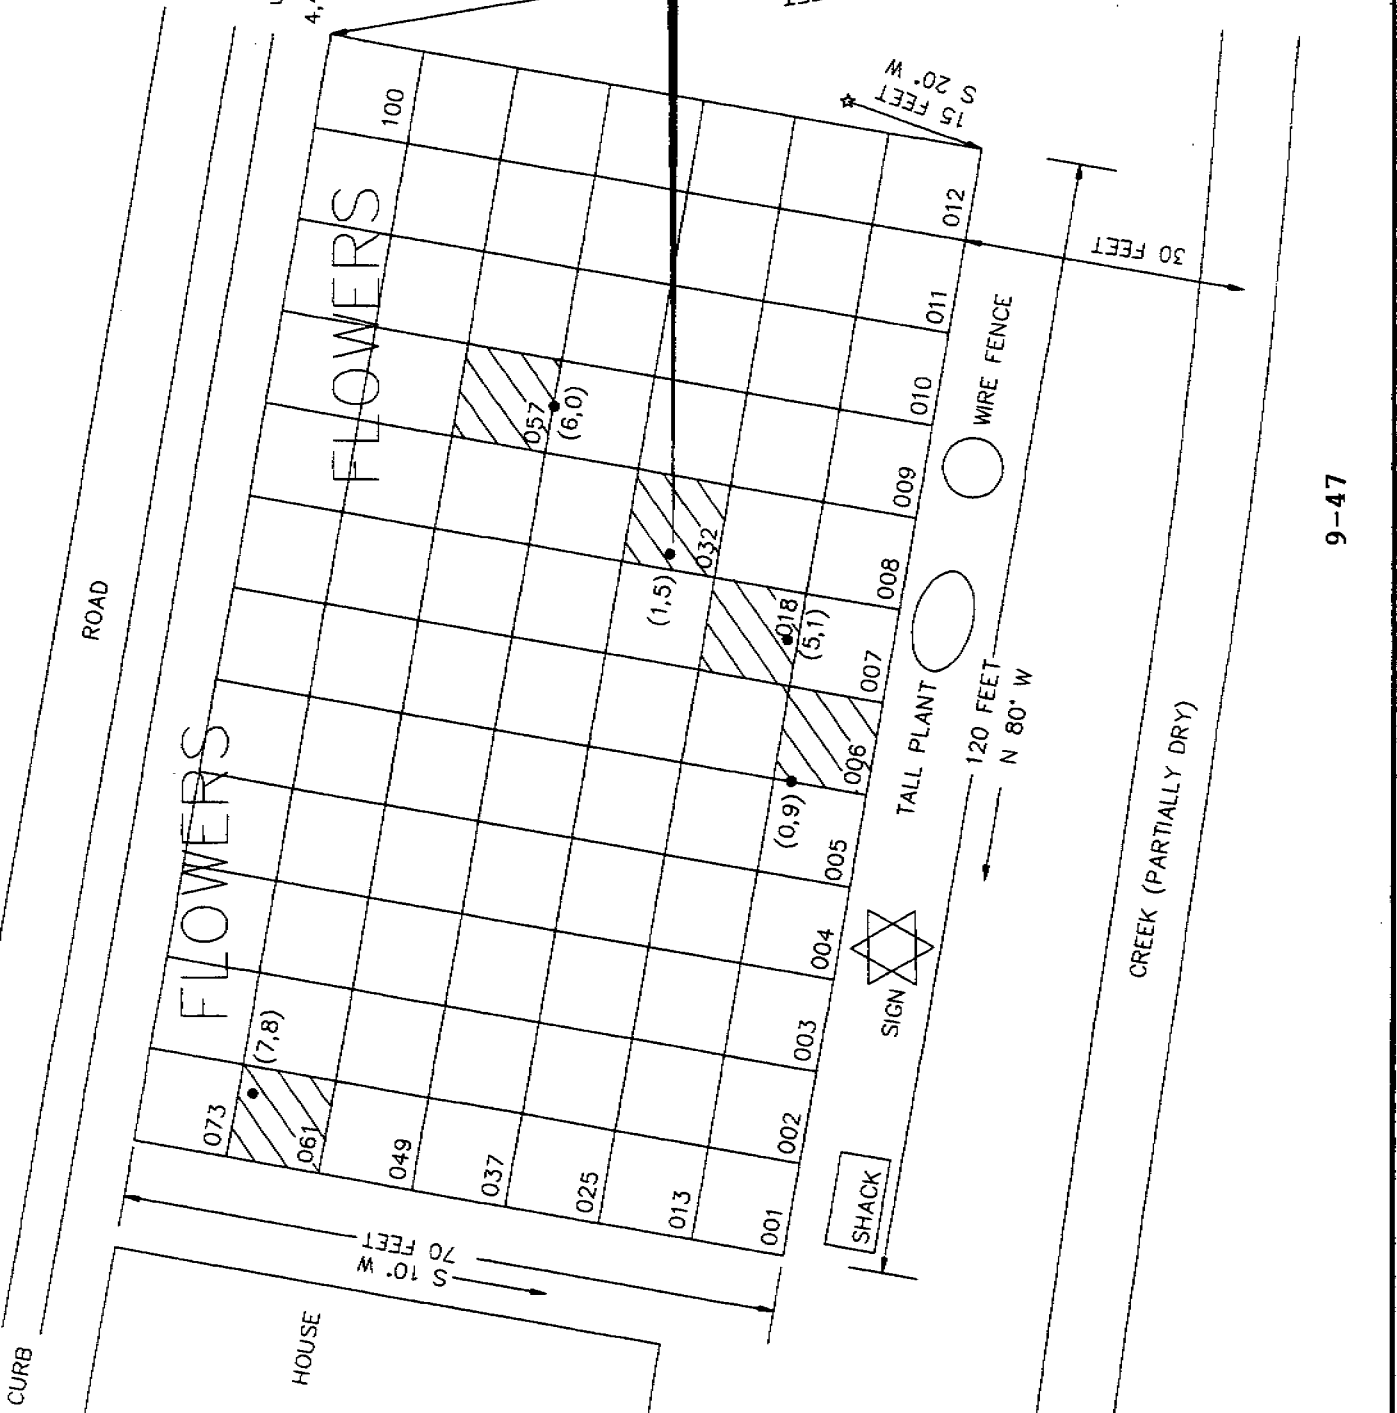
FIGURE 9-11
VEGETABLE GARDEN
BB-11
SAMPLE LOCATIONS

- LEGEND**
- ☐ RANDOMLY SELECTED BLOCKS
 - 010 BLOCK NUMBER
 - SAMPLE LOCATION
 - ☆ TREE
 - (4,2) X AND Y BLOCK COORDINATE OF SAMPLE LOCATION
 - ug/kg micrograms per kilogram
 - 4,4-DCE 4,4-Dichlorodiphenyl dichloroethene

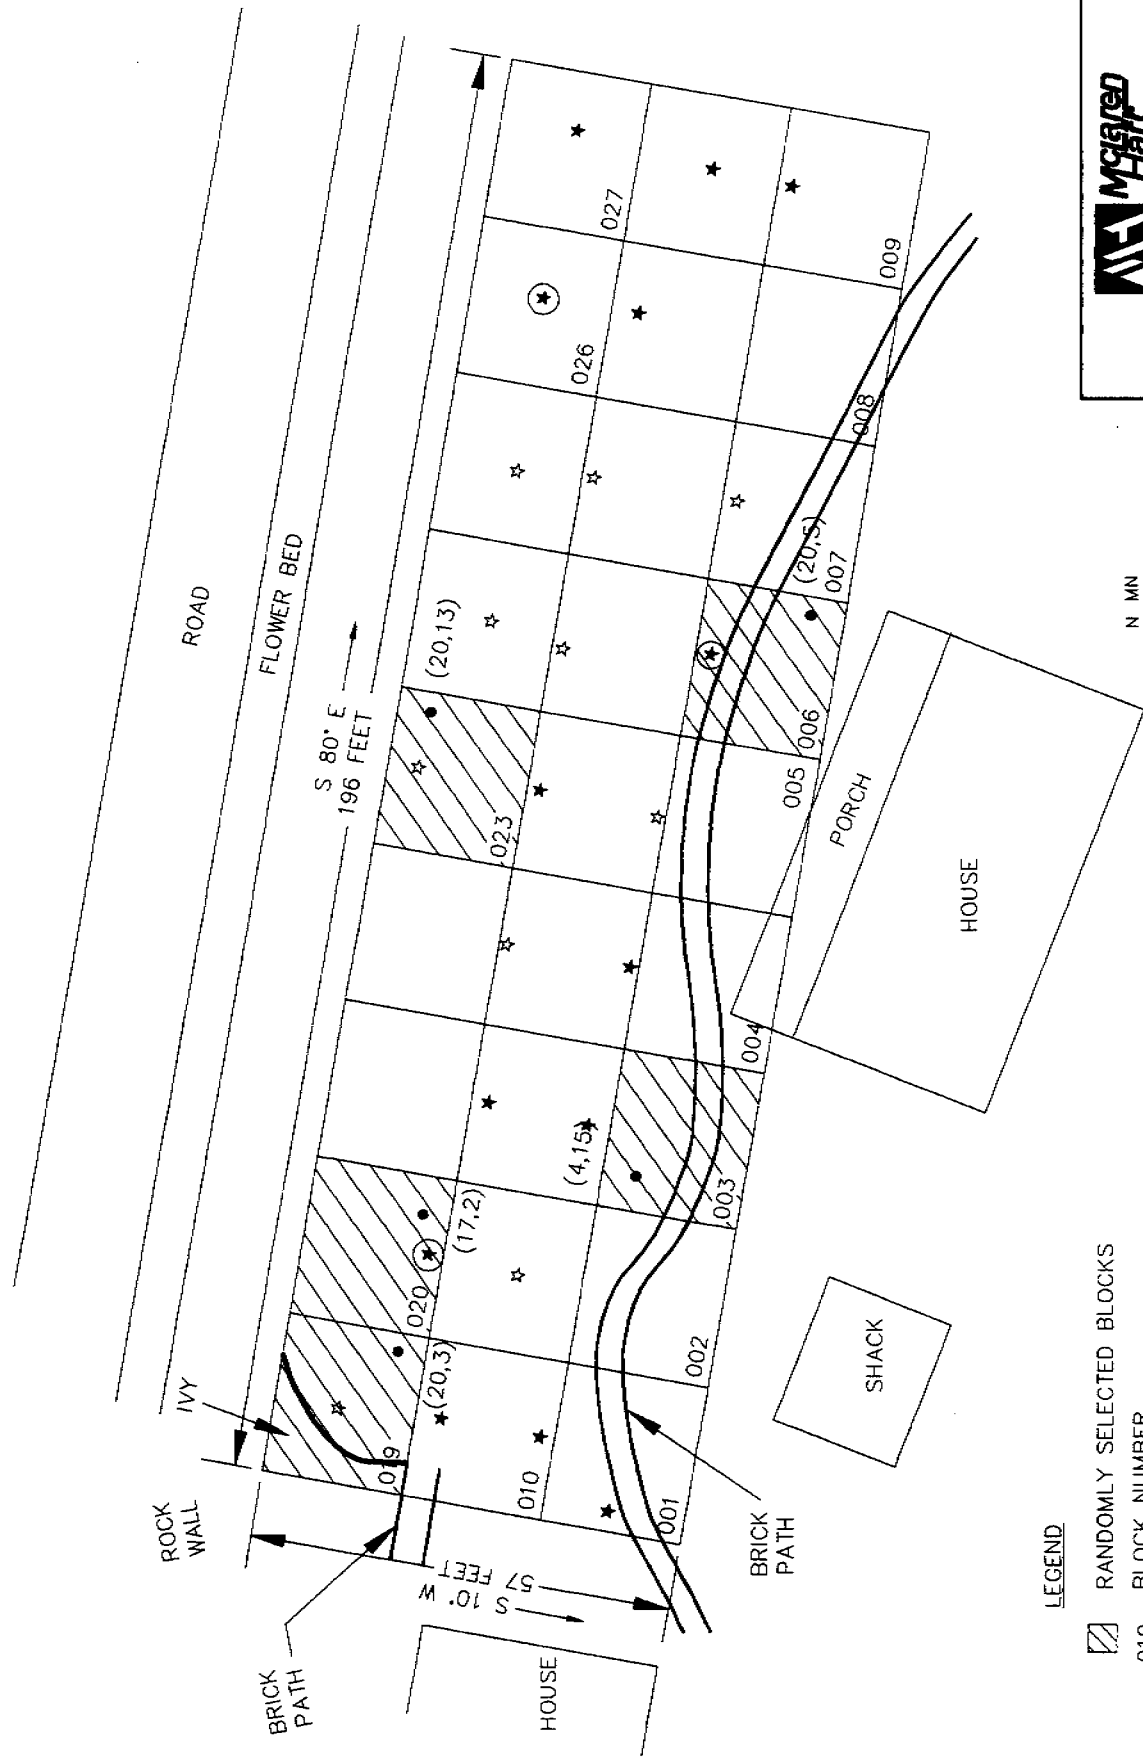
FIGURE 9-12
 MAIN HOUSE ORCHARD
 BB-12
 SAMPLE LOCATIONS

Cesium-137 was the only man-made radionuclide detected in the gamma scan analysis.

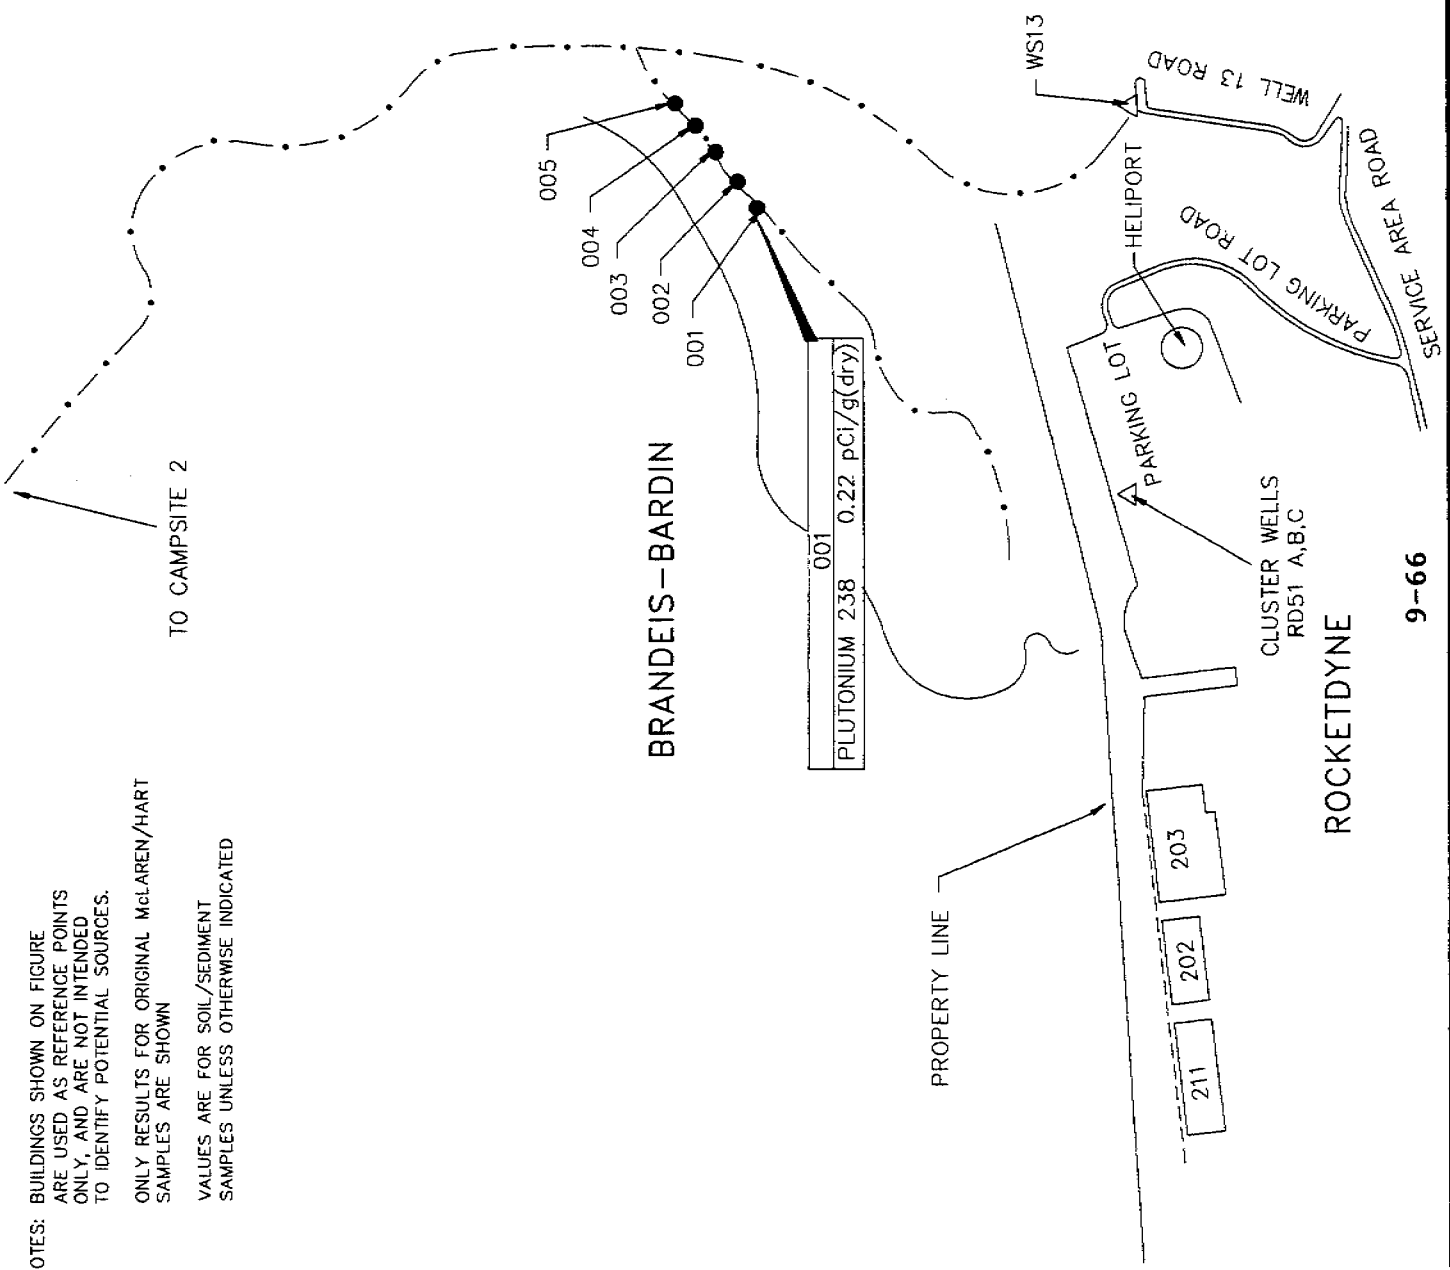
FIGURE 9-15
RD-51 WATERSHED
BB-15
SAMPLE LOCATIONS

- SAMPLE LOCATIONS
 - - - DRAINAGE
 - - - FENCE
 - ⬭ ROCK OUTCROPS
 - 001 McLAREN/HART SAMPLE LOCATION
- pCi/g(dry) picocurie per gram (dry)

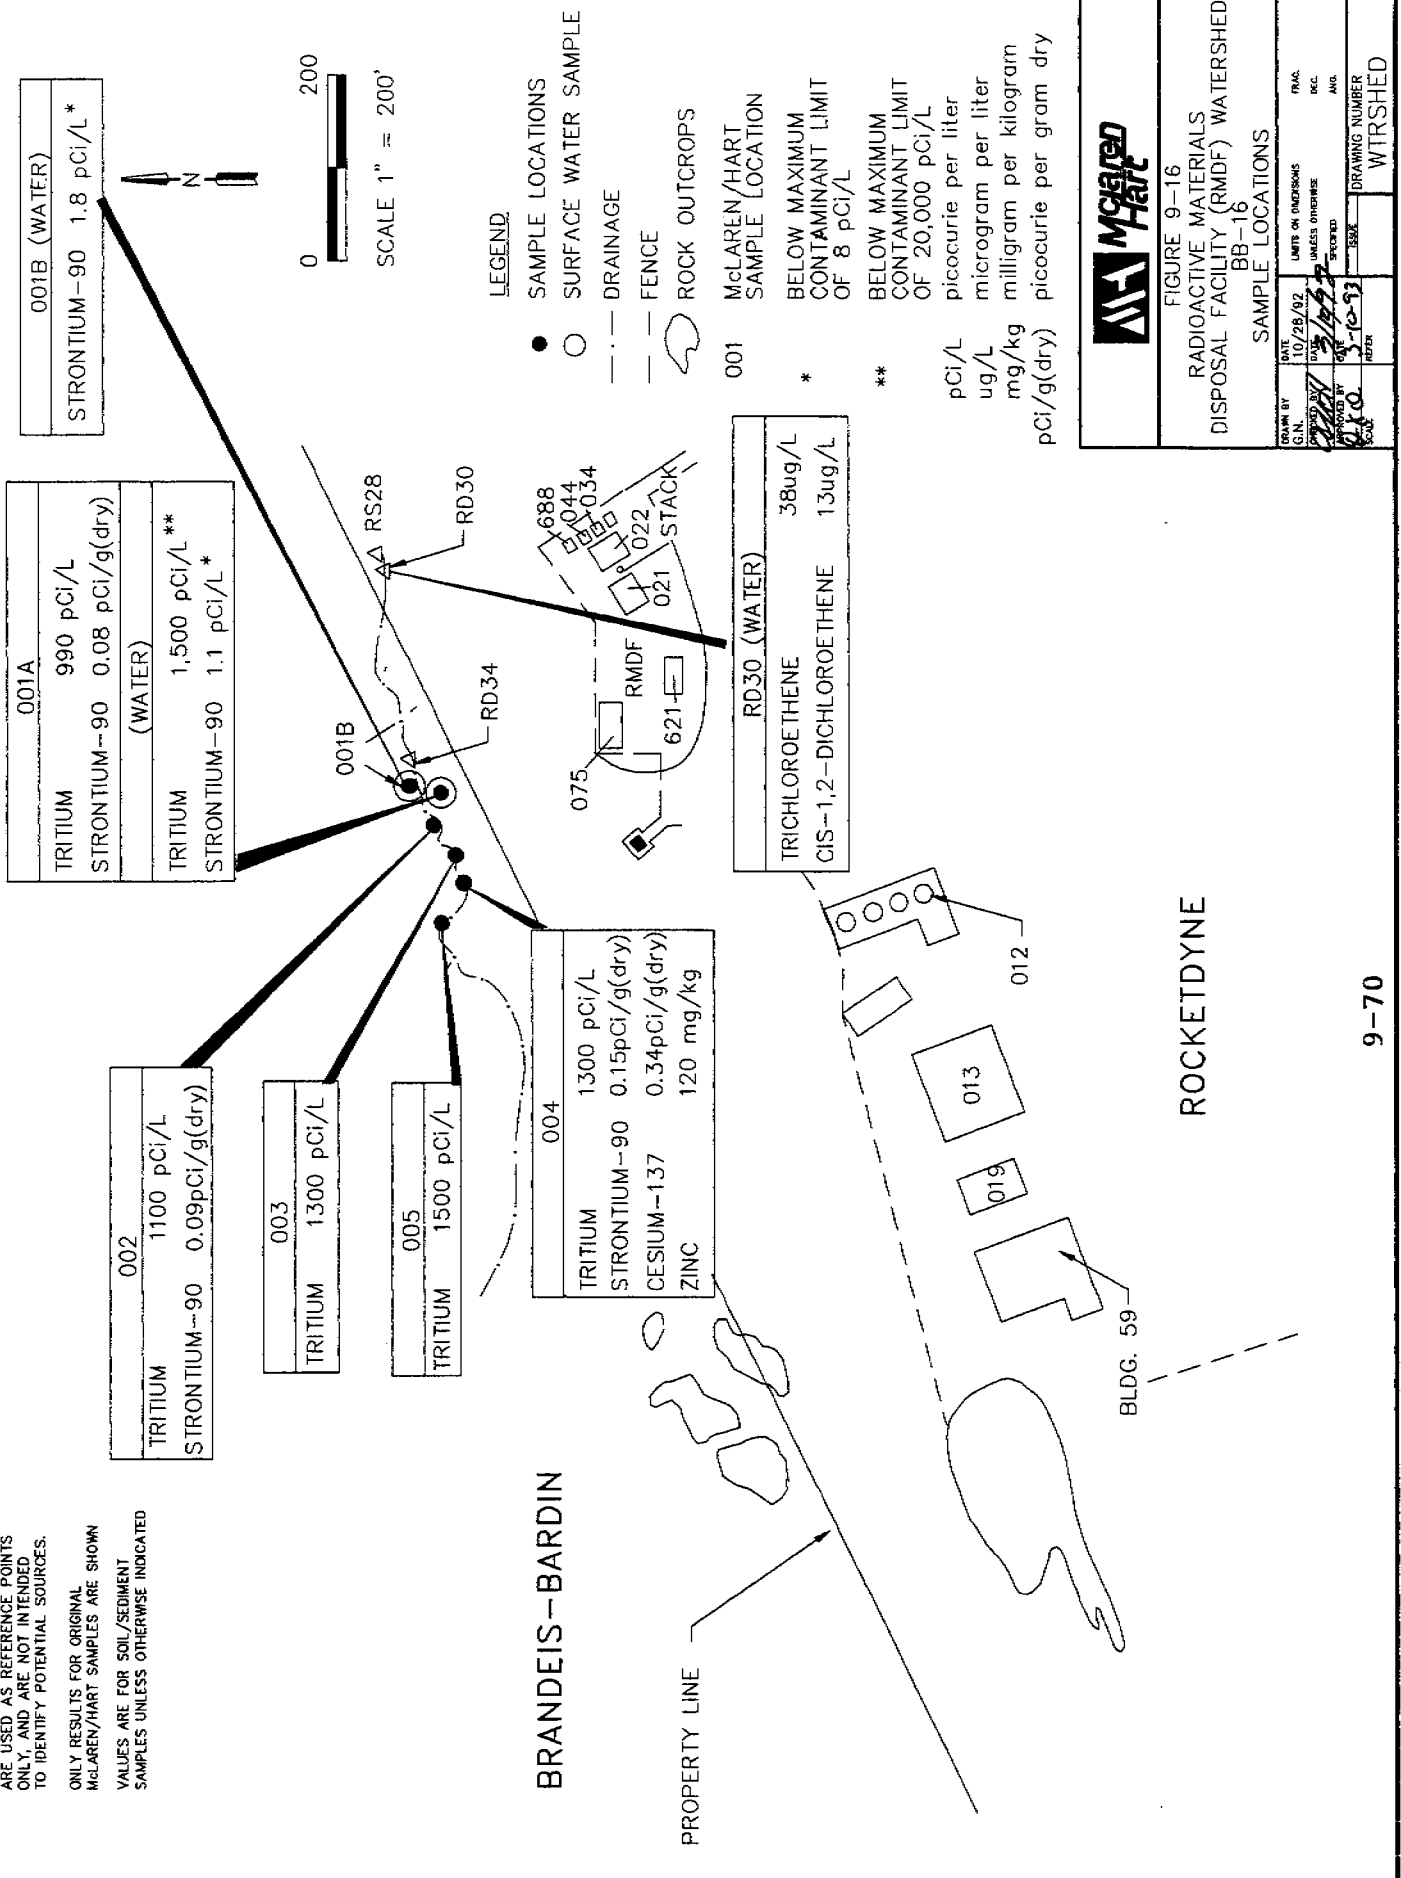
FIGURE 9-16
 RADIOACTIVE MATERIALS
 DISPOSAL FACILITY (RMDF) WATERSHED
 BB-16
 SAMPLE LOCATIONS

ONLY RESULTS FOR ORIGINAL McLAREN/HART SAMPLES ARE SHOWN VALUES ARE FOR SOIL/SEDIMENT SAMPLES UNLESS OTHERWISE INDICATED

Recommendations. It is recommended that the sediment deposit containing the mercury be removed by Rocketdyne and properly disposed. Additional sampling may be warranted, for example, to monitor the RMDF and Building 59 Watersheds. Recommendations will be solicited by Rocketdyne from the regulatory agencies, the SSFL work group, and the public after review of this report. Appropriate follow-up activities will be conducted after the recommendations are received.

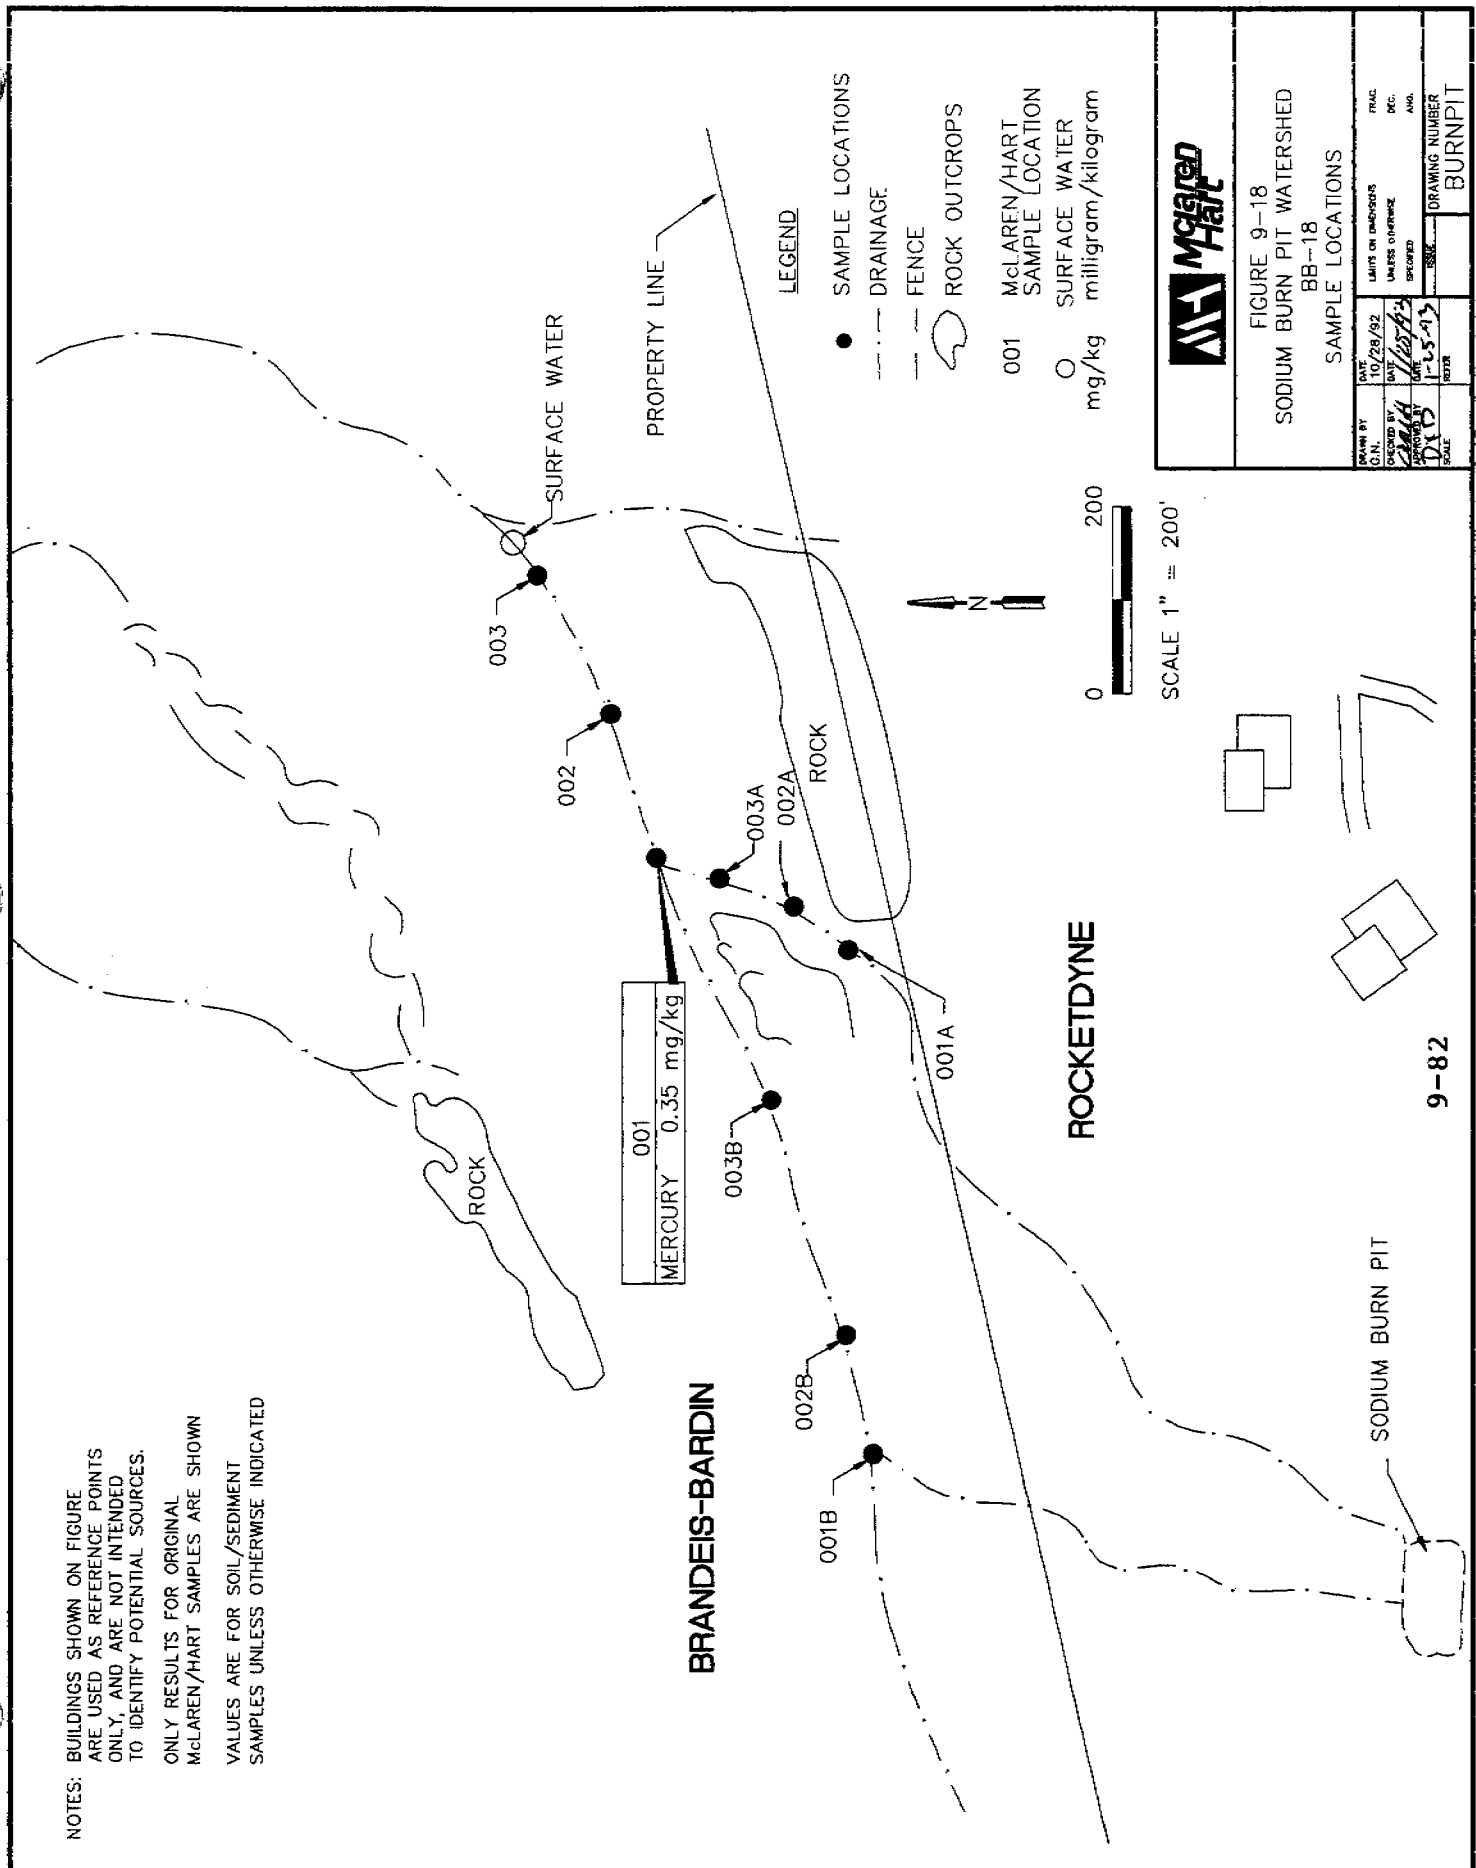
FIGURE 9-18
SODIUM BURN PIT WATERSHED
BB-18
SAMPLE LOCATIONS

Heavy metals from Rocketdyne activities were reported at two locations: lead in all five soil samples taken from the Former Rocketdyne Employee Shooting Range at the Conservancy ranging from 59 to 280 milligrams per kilogram of soil (mg/kg) and mercury in one of nine sediment samples at the Sodium Burn Pit Watershed at Brandeis-Bardin at 0.35 mg/kg. The Former Rocketdyne Employee Shooting Range was previously used for skeet and trap shooting practice and lead shot was visible on the ground throughout the area. Rocketdyne began cleanup of the lead shot on October 19, 1992. Mercury was known to be contained in the former Sodium Burn Pit, which is currently undergoing excavation and cleanup.

- ▶ Trichloroethene (TCE) in the groundwater at the Well by the Gate at the Conservancy;
- ▶ Lead in the Former Rocketdyne Employee Shooting Range at the Conservancy;
- ▶ Mercury in one sediment sample at the Sodium Burn Pit Watershed at Brandeis-Bardin; and

NOTES: BUILDINGS SHOWN ON FIGURE ARE USED AS REFERENCE POINTS ONLY, AND ARE NOT INTENDED TO IDENTIFY POTENTIAL SOURCES. ONLY RESULTS FOR ORIGINAL McLAREN/HART SAMPLES ARE SHOWN. VALUES ARE FOR SOIL/SEDIMENT SAMPLES UNLESS OTHERWISE INDICATED.
