**MULTI-MEDIA SAMPLING REPORT FOR THE
BRANDEIS-BARDIN INSTITUTE
AND
THE SANTA MONICA
MOUNTAINS CONSERVANCY
VOLUME I**

**ROCKWELL INTERNATIONAL CORPORATION
ROCKETDYNE DIVISION
6633 CANOGA AVENUE
CANOGA PARK, CA 91303**

**MCLAREN/HART ENVIRONMENTAL ENGINEERING CORPORATION
16755 VON KARMAN AVENUE
IRVINE, CALIFORNIA 92714**

MCLAREN/HART PROJECT NO. 29403-012

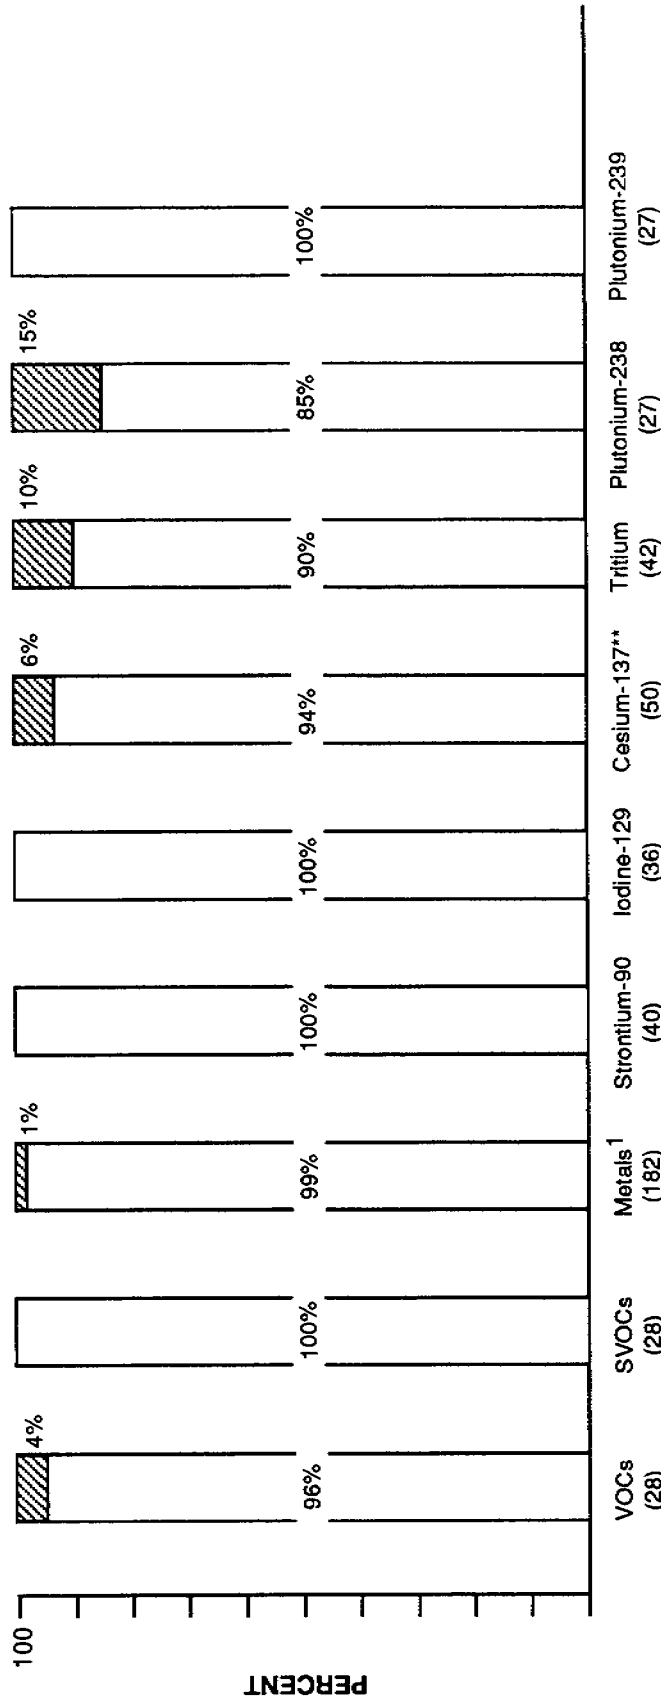
Figure 11-1
 Quality Assurance / Quality Control (QA/QC) Summary for Key Analyses
 (Soil/Sediment Samples)

ANALYSIS
 (Number of QA/QC Samples)

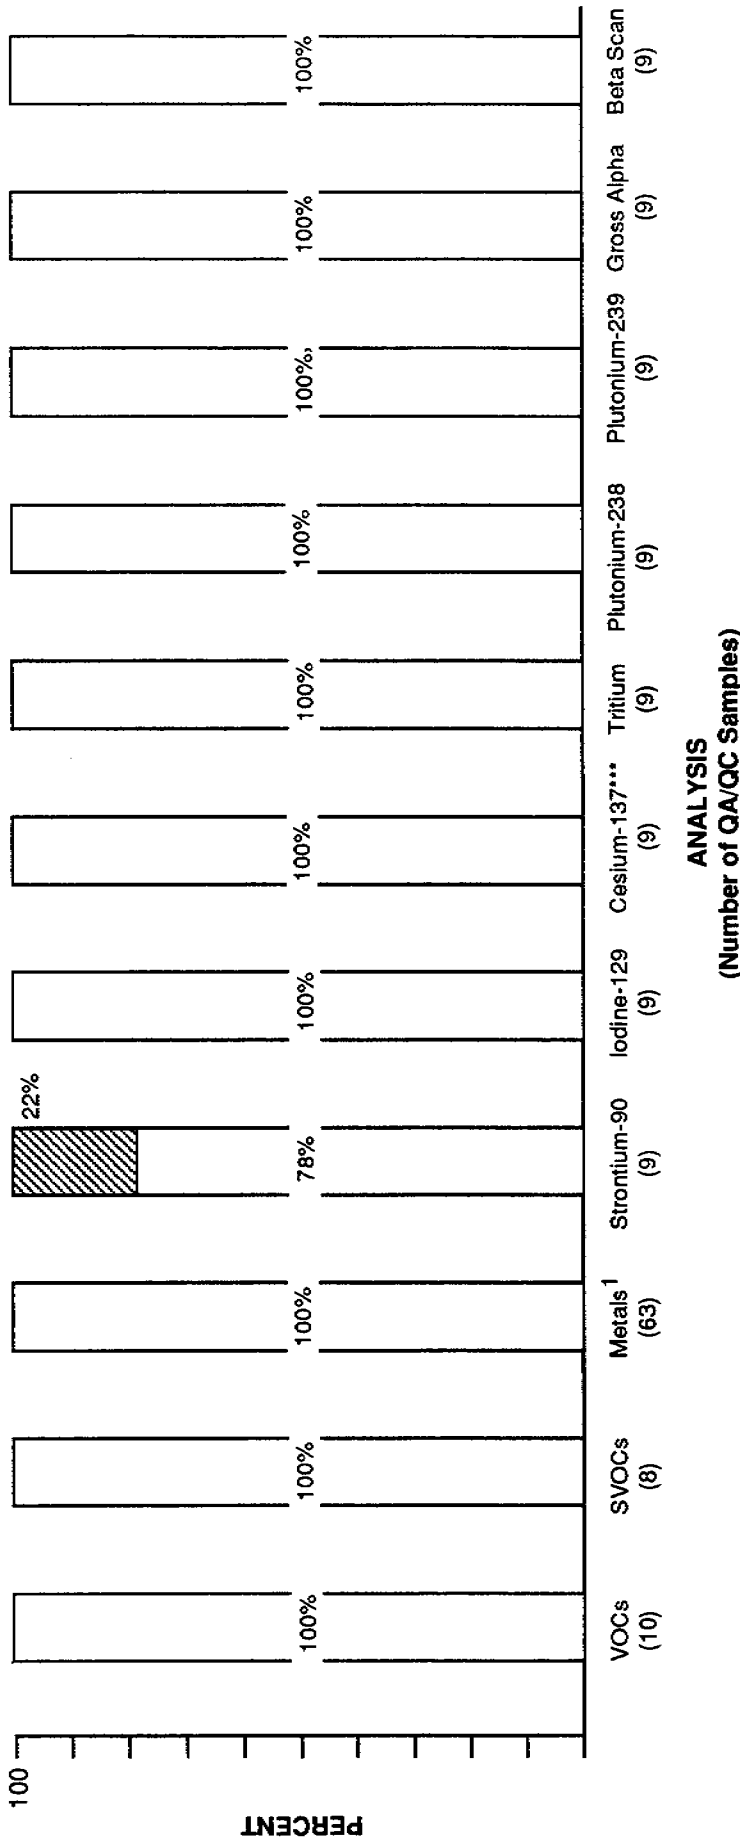
Figure 11-2
 Quality Assurance / Quality Control (QA/QC) for Key Analyses
 (Water Samples)**

ANALYSIS
 (Number of QA/QC Samples)

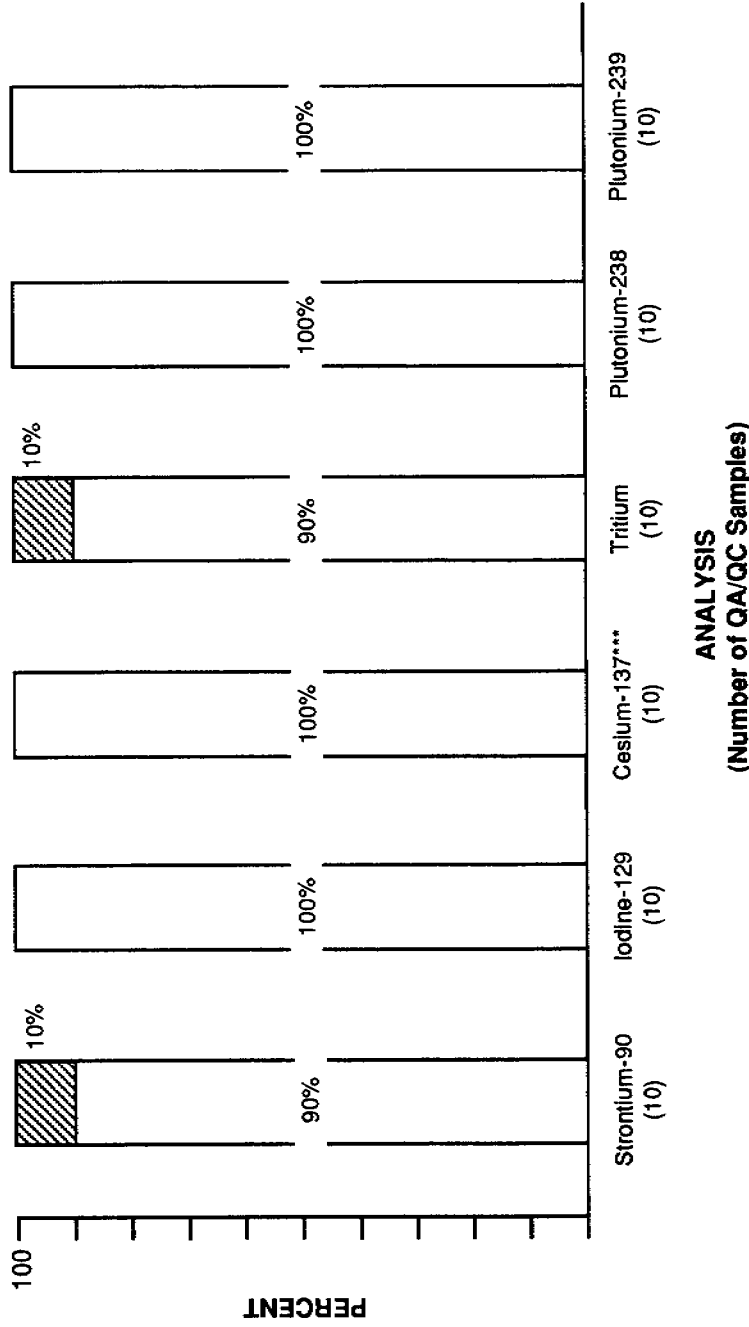
Figure 11-3
 Quality Assurance / Quality Control (QA/QC) for Key Analyses*
 (Fruit Samples)**

In Agreement ¹
 Not in Agreement

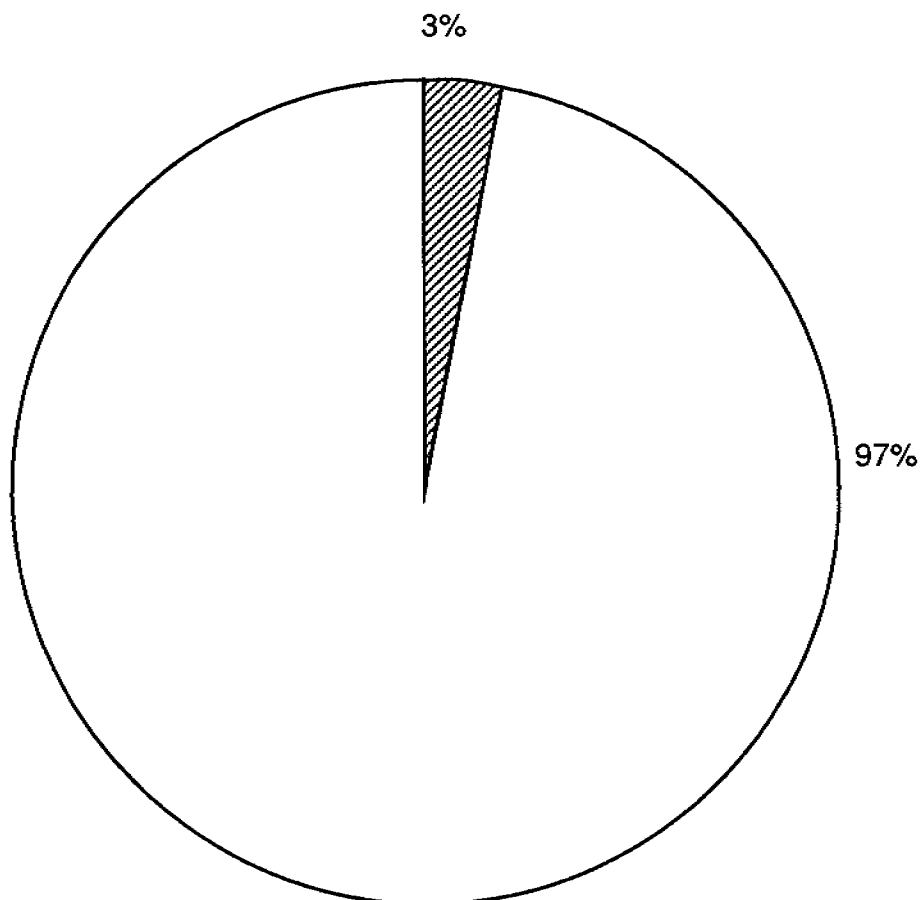
Figure 11-4
Overall Quality Assurance / Quality Control (QA/QC)
Summary for All Media* / All Analyses**

* All media includes soil/sediment, groundwater, surface water and fruit samples (i.e., avocado, oranges, lemons and tangerines).

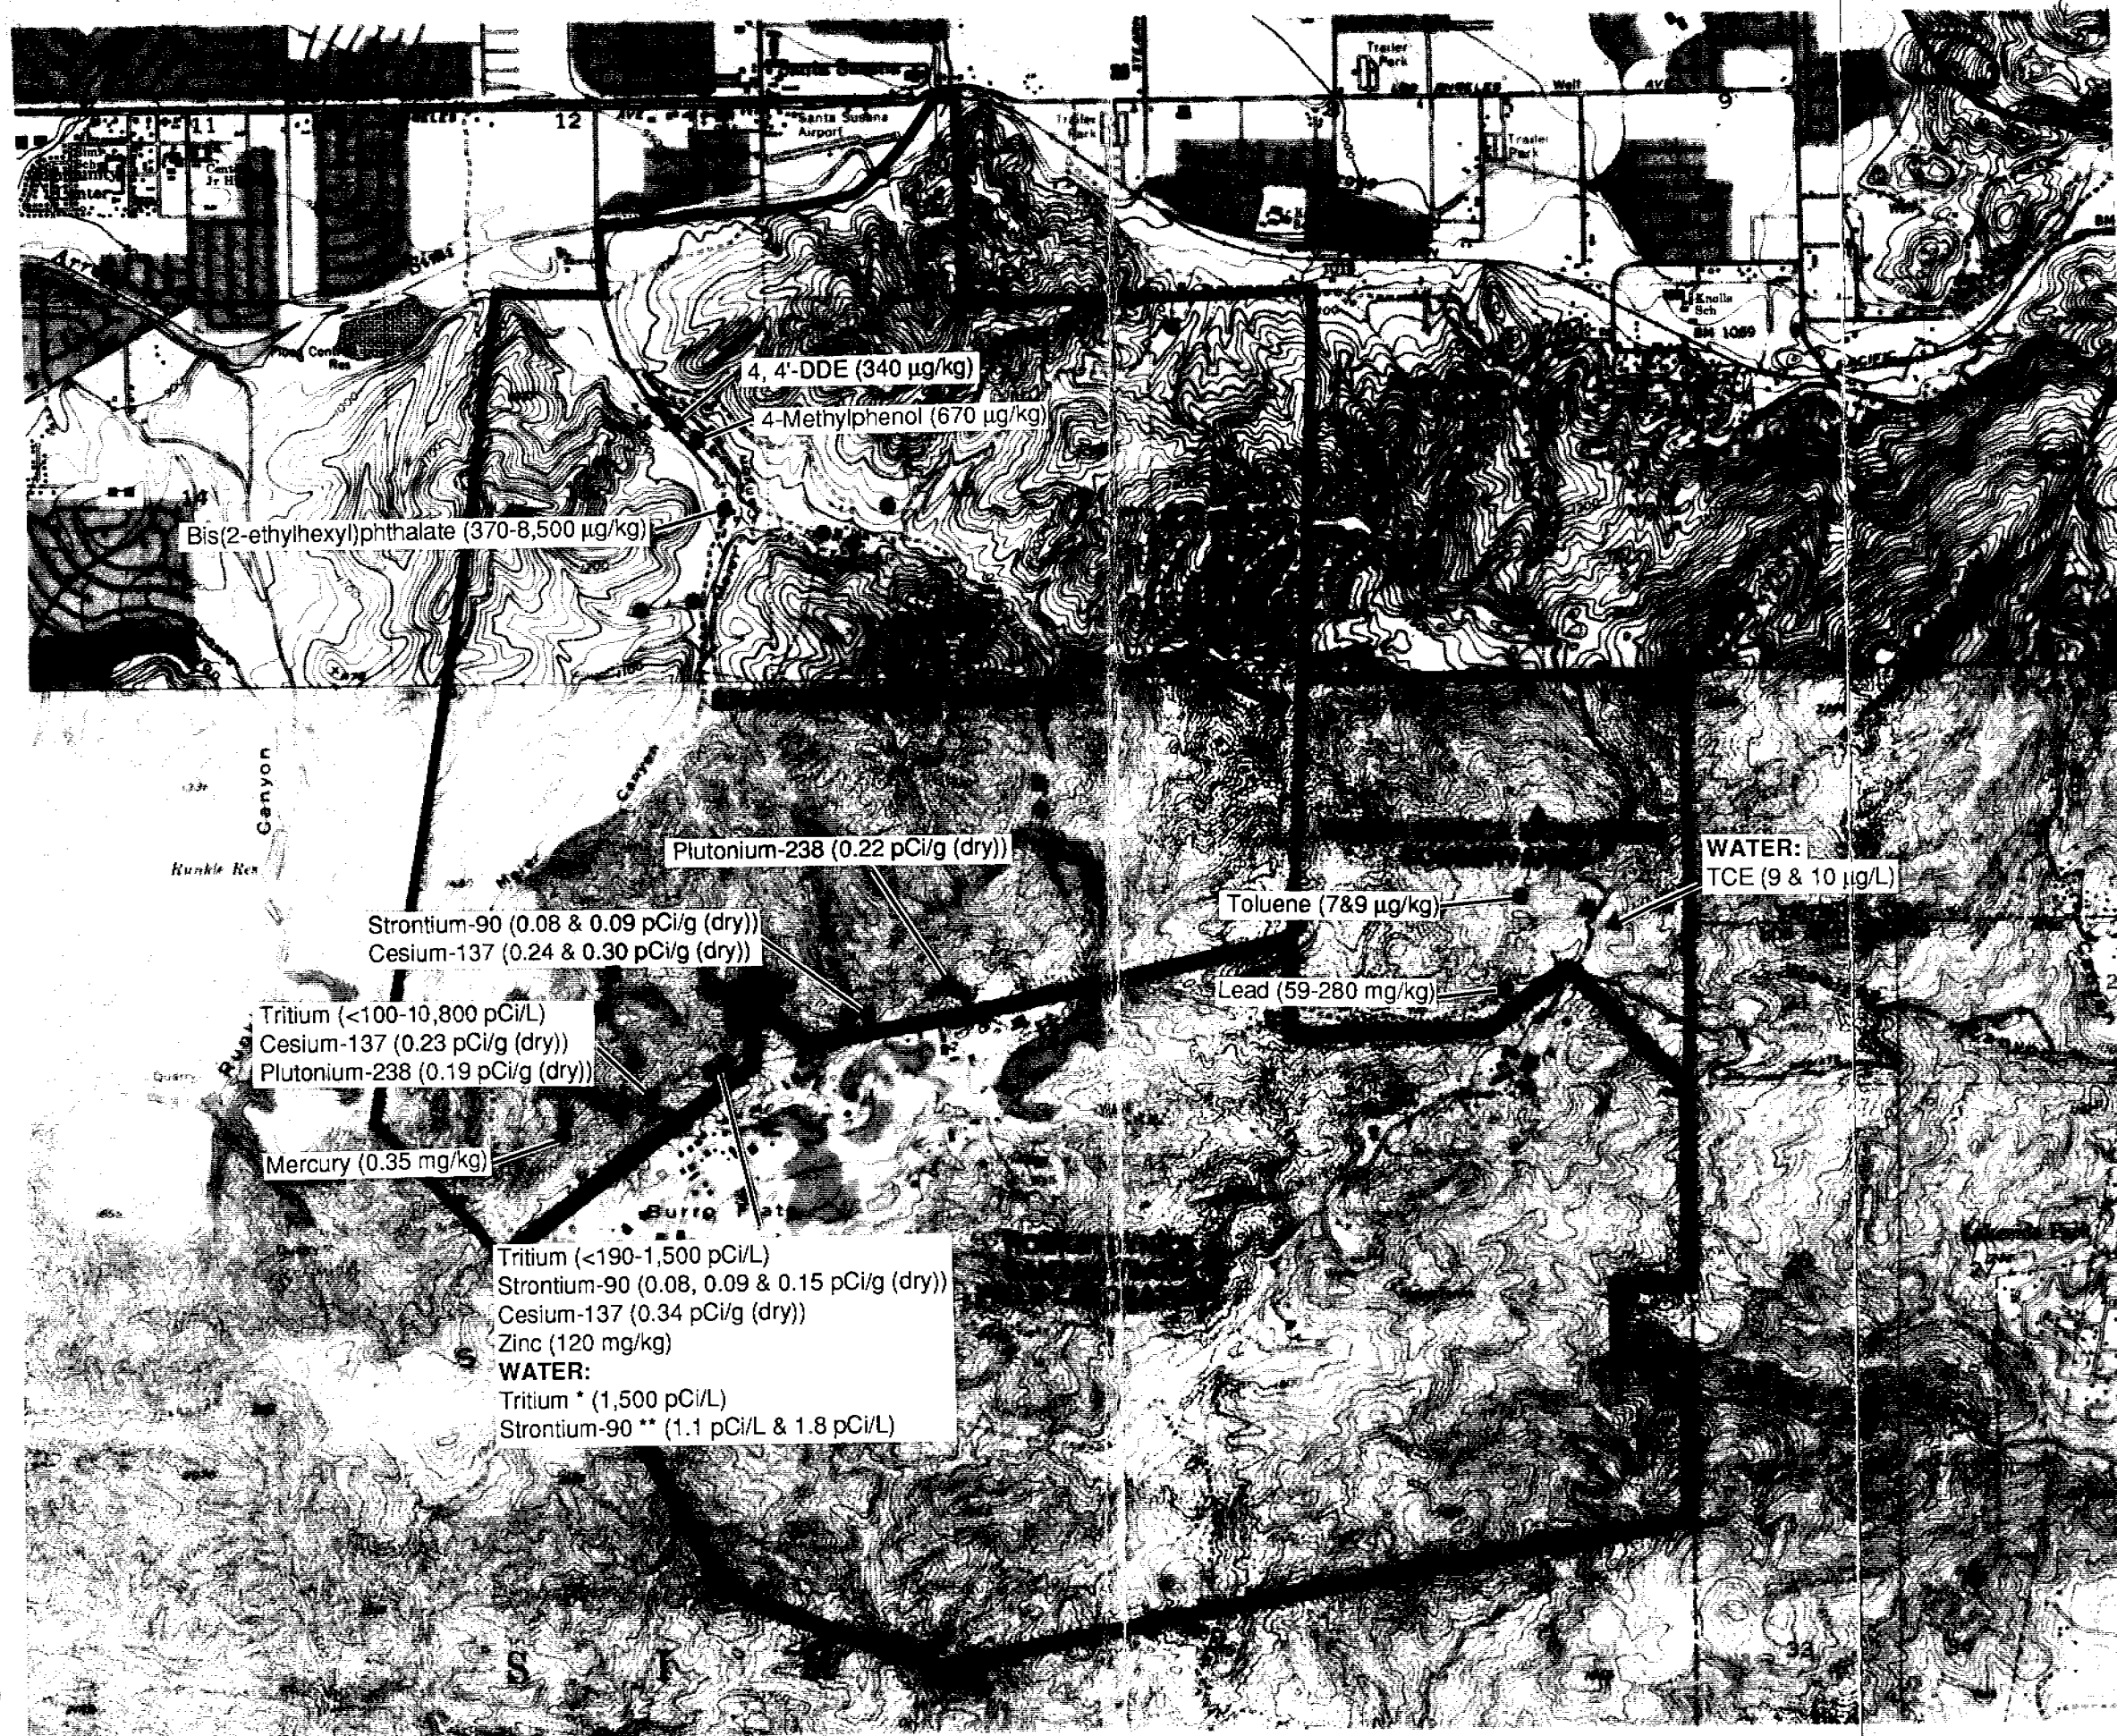
FIGURE 12-1
SUMMARY OF
MULTI-MEDIA SAMPLING

NOTE: Only McLaren/Hart results are shown. Results are for so samples unless otherwise indicated.
